CONSULTING ARBORIST

January 19, 2007 Registered Consulting Arborist #381 • American Society of Consulting Arborists

Tree Inventory and Assessment: Villa Flores Apartments 601 East Anapamu St., Santa Barbara

RE: Villa Flores

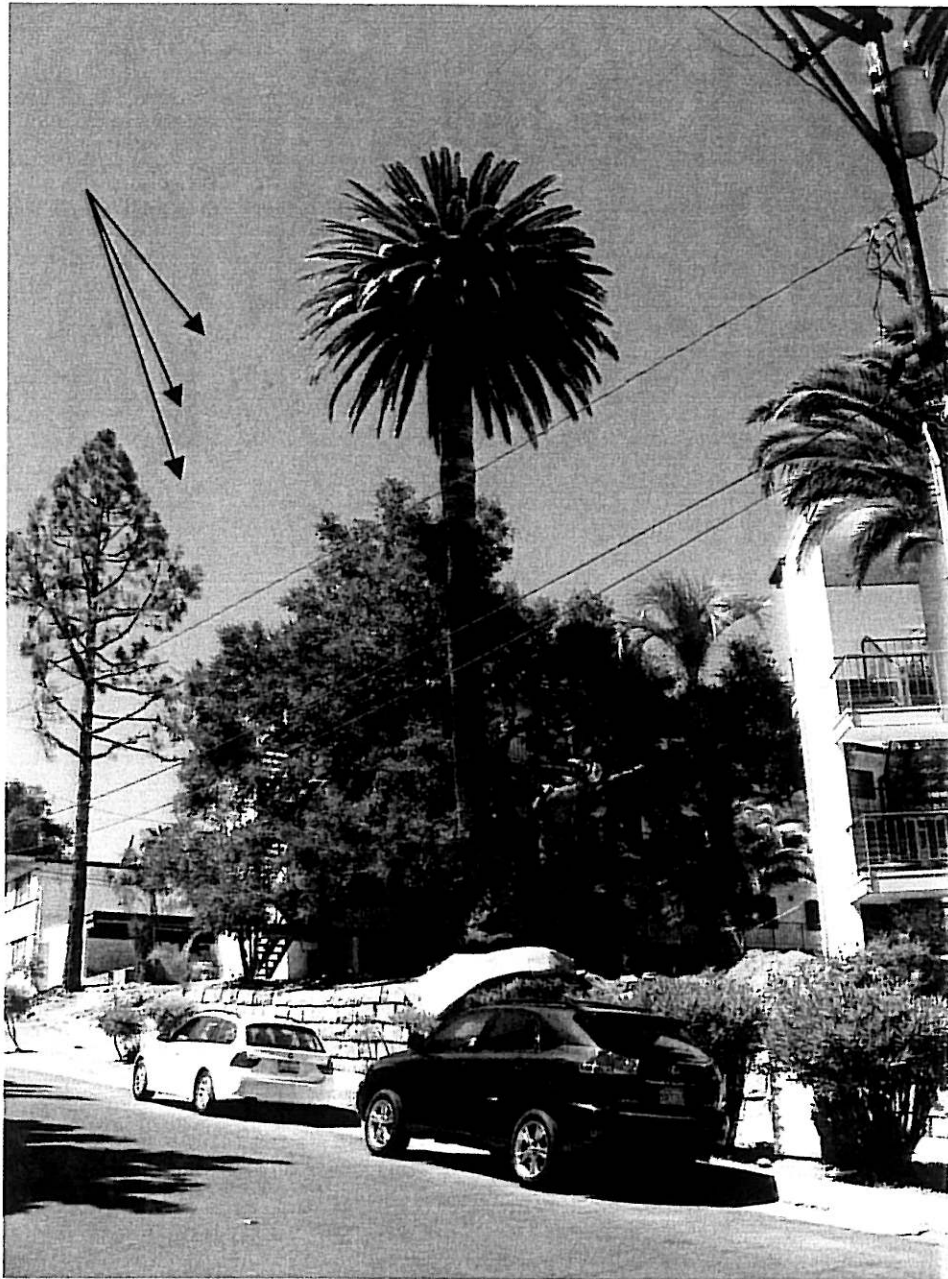
4. The second palm is closer to the wall with roots that also grow through the spaces between stones.
5. The larger tree (approximately 75' tall) is taller than the adjacent high voltage wires and is precariously close.

Photo 1: View of the larger palm. Arrows point to high voltage wires. The lower wires are low voltage electrical, telephone and cable TV. Carpet covers a portion of the exposed root ball. The smaller palm is at the upper right edge of the photo by the pole.

- Restore the wall as necessary but without incorporating the sections near the palm trees.
- When restoring a stairway from the sidewalk to the complex, place it to the north end of the wall as far from the oak tree as possible.

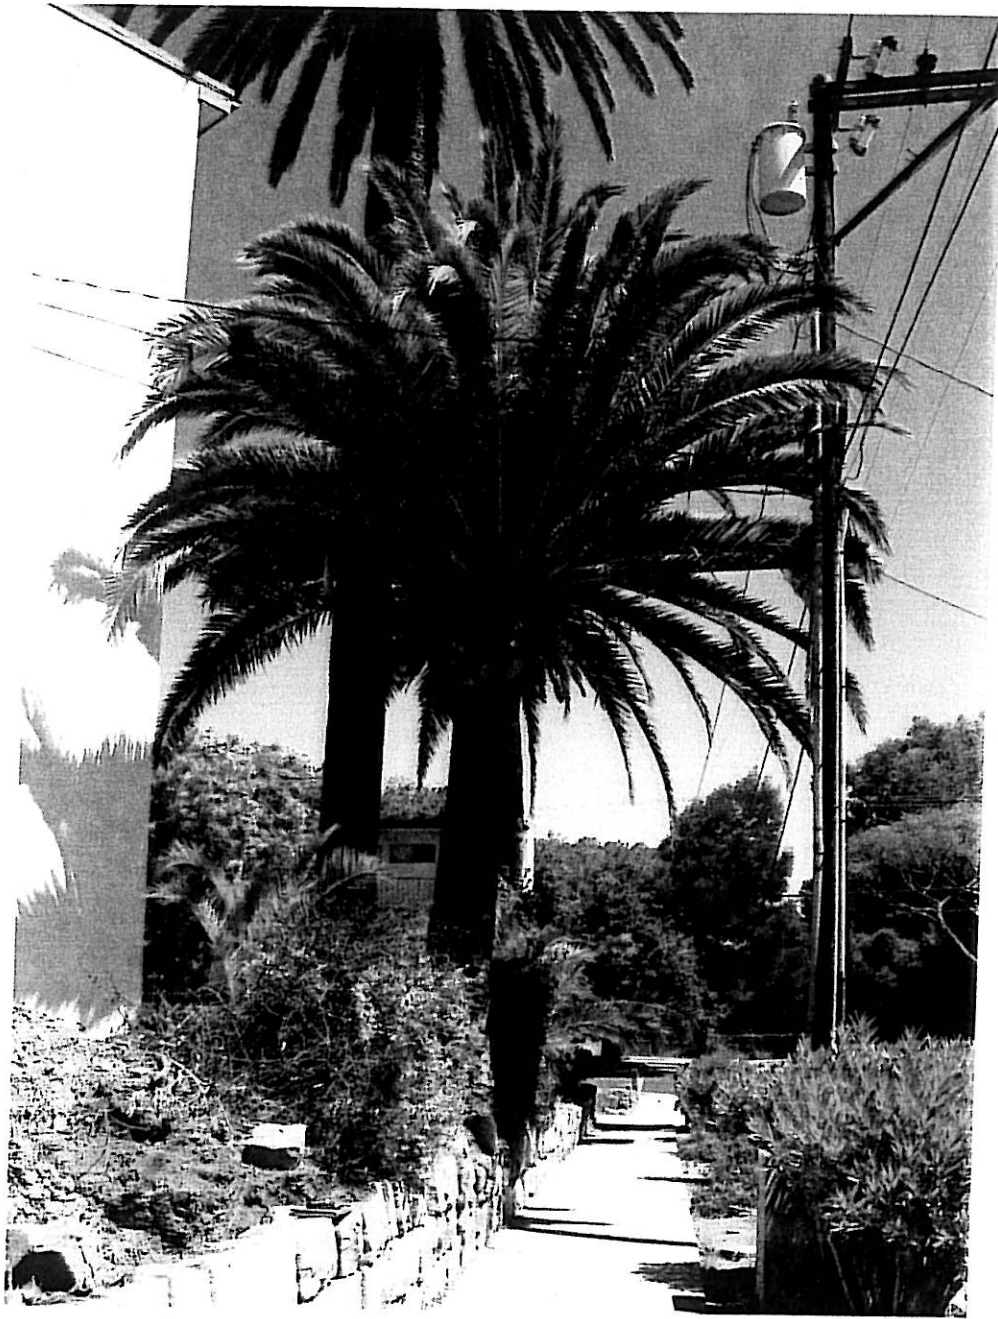
6. The second palm is shorter (approximately 35' tall) but has palm fronds that grow into the low voltage electrical, telephone and cable TV wires.
7. A grounds crew removed a significant section of the rock wall and stairway, thus exposing the large root mass of the larger palm. It has since been watered and covered with carpet to resist water loss.

Photo 2: The smaller palm. Note its location next to the wires and pole.

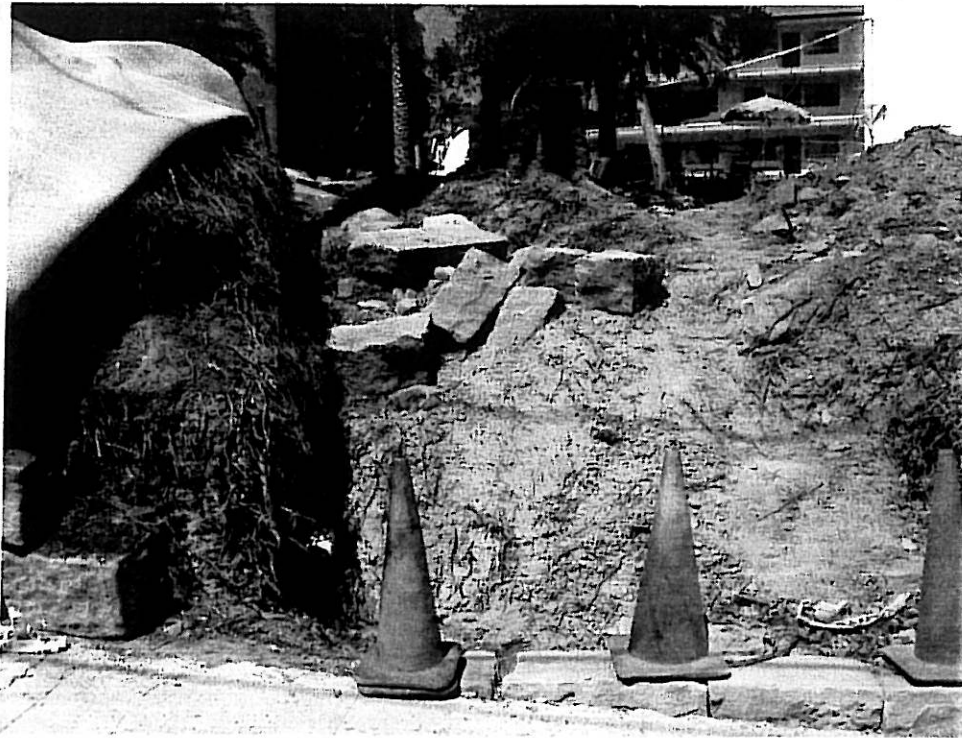
Photo 3: A close up of the removed section of the wall and the exposed massive root ball.

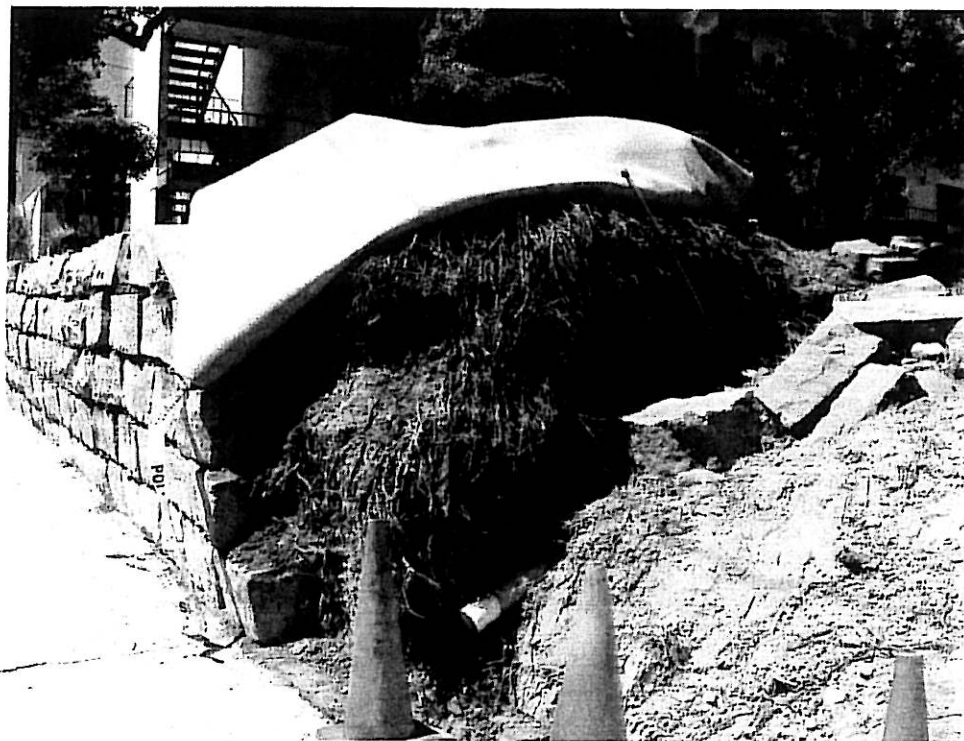
My concern lies with disassembly of the existing stonewall that supports these massive palms so close to the sidewalk, street and high voltage wires. There is a high potential for movement of the root ball during the restoration of the wall and the consequences could be tragic. When unsupported, the weight of the tree and root ball could cause shearing of underlying soil, resulting in sliding or possibly toppling to the west into the high voltage wires and road.

Photo 4: Note the proximity of the root mass to the wall.

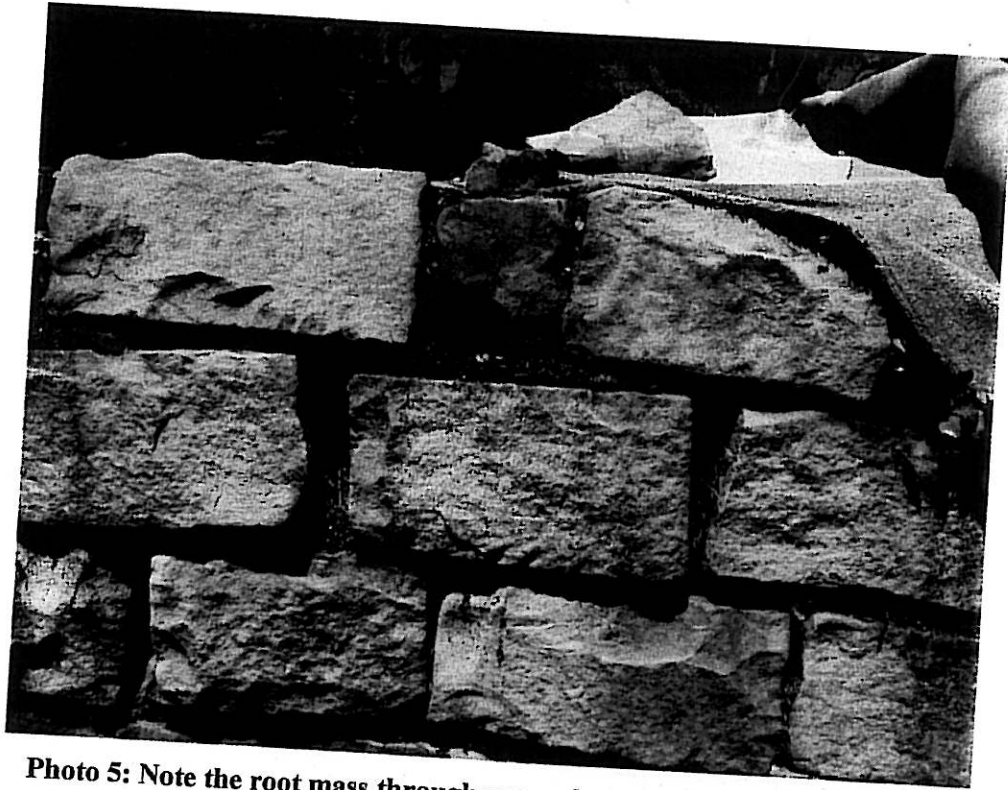
west side where it grows into the wall. Roots are visible through the spaces between stones in the wall.

Photo 5: Note the root mass through spaces between the stones in the wall.

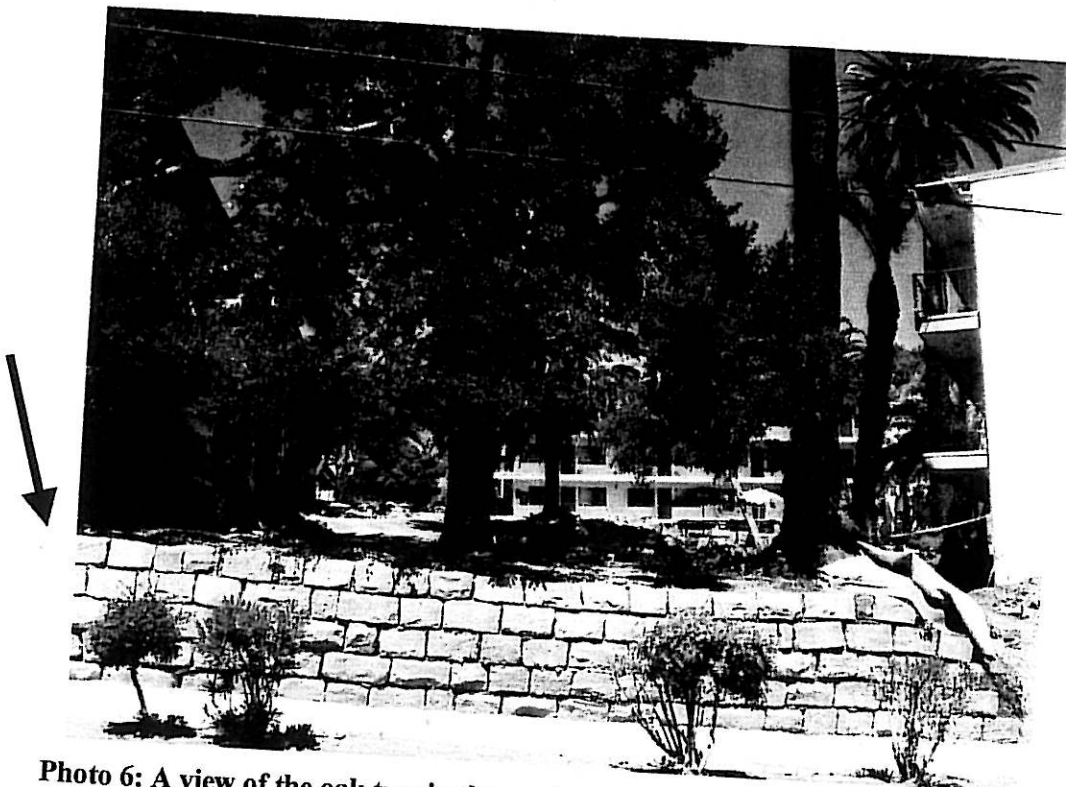
8. There is a 28" DBH oak near the larger palm but much further back from the center section of the wall.
9. According to Katie O'Reilly Rogers, the Architectural Review Board of the City of Santa Barbara has required restoration of the entire wall. This will require disassembling the existing wall and rebuilding it. In the process, roots of both trees will be cut and the retained soil will become exposed and unsupported.

Photo 6: A view of the oak tree in the center. A new stairway should be located to the left (north end) of the wall. Arrow
